# Beckfoot Heaton School - Accessibility Action Plan.

Updated: 10/01/2025

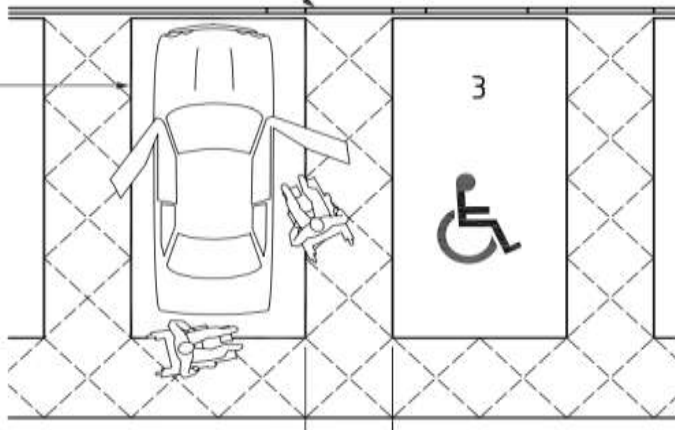
Item Ref.	Details / Issue	Recommendation	Est Cost	Action Taken
2.3	The position of the bays would not allow both bays to be used at the same time.	<p>The bays should be repositioned, parallel to one another, to allow both bays to be accessed at all times.</p> <p>The designated accessible parking should be clearly marked out at least 2.4m wide x 4.8m long plus a 1.2m side transfer zone at the side and end of the bay.</p>

M	Only 1 bay is for parking other is for parent to drop off disabled child.

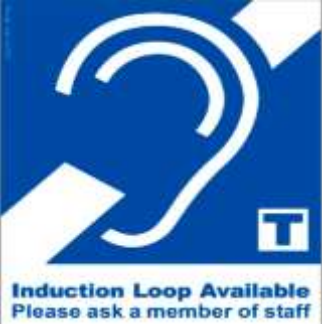
<p>6.5</p>	<p>An induction loop system was not identified at the reception area, which could assist people who have hearing loss.</p>

<p>The sign is blue with a white ear icon and a white 'T' in a square. Below the icon, it reads 'Induction Loop Available' and 'Please ask a member of staff'.</p>	<p>Install an induction loop to the reception desk. Install signage indicating the availability of the facility and ensure that staff members are aware of how to use the system.</p> <p>Direct Access has its own bespoke desk induction loop for people with hearing impairments. We are able to supply, install and provide brief training. Please see here and contact us for more information - <a href="https://directaccessgp.co.uk/induction-loops-and-hearingenhancement-systems/">https://directaccessgp.co.uk/induction-loops-and-hearingenhancement-systems/</a></p> <p>BS8300 - A hearing enhancement system, using induction loop, infrared or radio transmission, should be installed at service or reception counters where the background noise level is high.</p>	<p>M</p>	<p>Portable system available.</p>

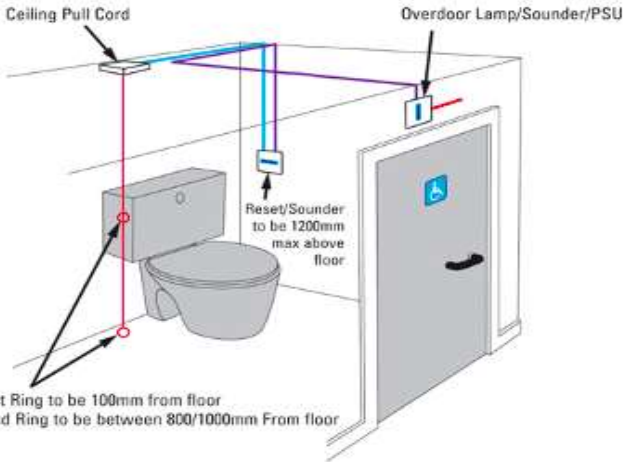
<p>13.10</p>	<p>Bins were identified in the transfer zones of the accessible WCs. This could prevent a wheelchair user from adopting the required transfer techniques to access the facility.</p>	<p>It is vitally important and is strongly recommended that a management procedure be implemented to ensure that accessible WC facilities are always kept clear.

This will enable wheelchair users to adopt the many transfer techniques available to them in which an accessible WC is designed to provide. Without a free transfer area, a wheelchair user is highly unlikely to be able to use a facility.</p>	<p>M</p>	<p>Bins relocated.</p>
<p>13.11</p>	<p>The cord alarm was marginally high from ground floor level in facility 270.</p> <p>The years 5 and 6 facility featured a cord alarm that was tucked behind a pipe, high from ground floor level.</p> <p>If a cord alarm is not within a suitable distance from ground floor level, a distress call may go unnoticed.</p>	<p>Implement a management procedure to ensure that cord alarms are always kept loose and not tied up.

<p>N</p>	<p>Cord untied in Green base Toilet</p>

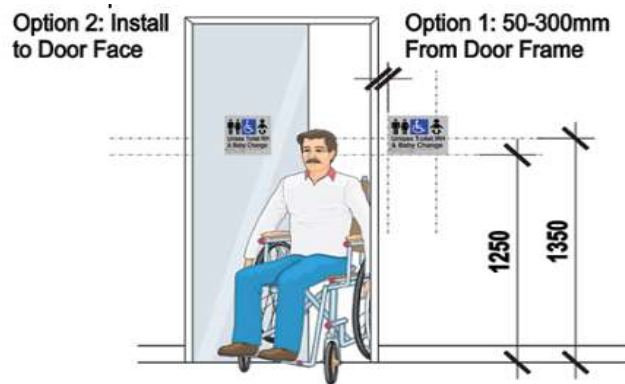
15.3

Some WC facilities were suitably signed with pictorial information.

The signage on facility 42 was slightly damaged.

The Hygiene Room 270 was not suitably signed for its purpose.

The WC facility 171 in years 5 and 6 was not suitably signposted.

The appropriate toilet signage should be provided. As well as signage on the toilet doors, there should also be signs indicating where the accessible WCs are located.

Raised lettering / Braille Toilet signs added to 3 doors 263,270 & 171

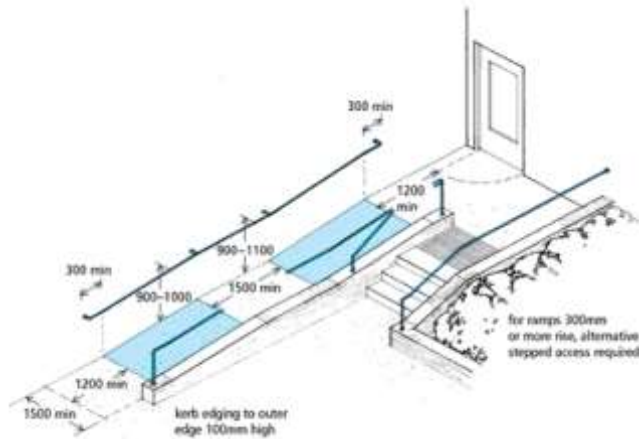
3.1

The ramps leading towards the key stage two playground, from both the key stage one and key stage two classrooms were long with no level landings. Contrast was not provided to these ramps to indicate a change in gradient.

The ramp should be subject to remedial works to reduce the gradient to a reasonable slope that can comply with BS8300 and ADM-2:1.26 requirements.

Any permanent ramp must be a maximum 1:12 over a maximum going of 2m, it should be a minimum 1.2m wide and feature 1.2m landings at head and foot, handrails to both sides and a contrasted sloped surface.

Colour contrast should be added to the surface of the ramps.

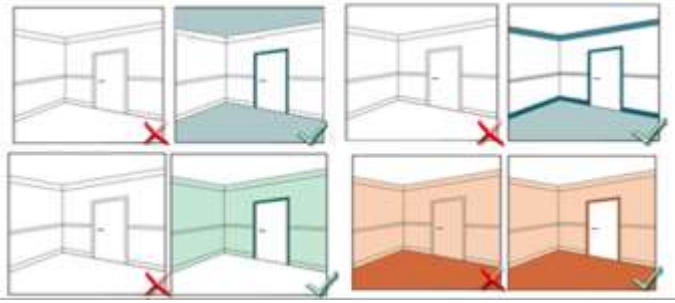
<p>7.4</p>	<p>Most areas of flooring had suitable junctions.</p> <p>A slightly damaged raised area of flooring was developing in room 223, which could become a trip hazard.</p>	<p>Any matting should either have its surface level with the adjacent floor finish or, if surface laid, be of a type that has a rubber backing and chamfered edges. Ideally surface mats should be securely fixed to the floor at their edges and at any joints, to avoid the risk of tripping or slipping and movement caused by heavier wheelchairs.</p>	<p>M</p>	<p>Repaired.</p>
<p>8.1</p>	<p>Most internal doors were well contrasted against the surroundings.</p> <p>The fire exit doors across KS1 were not well contrasted against the surroundings frames.</p> <p>The exit door by area 21 was not well contrasted against the surrounding frame.</p> <p>Contrast could assist people who are partially sighted in locating the door.</p>	<p>Ideally all doors should have contrast against the surroundings upon which they are seen. This could be achieved by painting the door frames a contrasting colour. Adding colour contrast will aid people with impaired vision.</p>

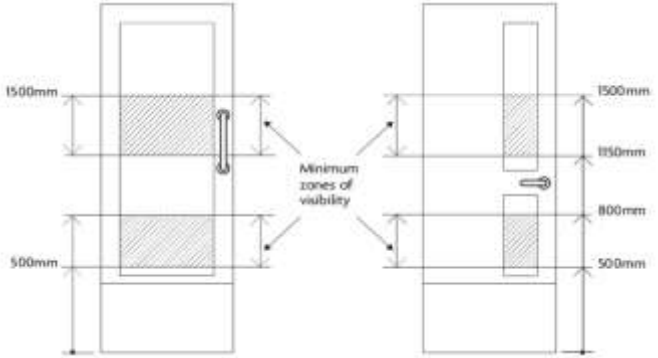
<p>8.3</p>	<p>Most areas of the school featured doors with suitable vision panels.</p> <p>The doors in zone 4 featured high vision panels, which could be a collision hazard for wheelchair users and people who are short in stature.</p>

<p>A rolling refurbishment programme should be implemented to install new BS8300 compliant doors with vision panels to zone 4.</p> <p>☐</p> <p>Vision panels need to be included in frequently used doors where privacy (toilets etc.) is not required with a minimum visibility zone between 500mm and 1500mm from floor level and located at the side of the leading edge.</p> <p>☐</p> <p>Glass should comply with BS6206.</p> <p>☐</p> <p>It is recommended that site management implement a procedure to ensure that the temporary notices are not on the vision panels. This will prevent a potential collision hazard.</p>	<p>M</p>	
<p>8.4</p>	<p>Door and a half systems were used across many corridors within the school.</p> <p>Double doors into 212 may not provide a sufficient width when only one leaf is open.</p> <p>Double doors leading outside, by 197, were approximately 740mm.</p> <p>Double doors towards zone 5 may not provide sufficient width when only one leaf is open.</p> <p>Narrow double doors were identified into the area opposite unisex WC facilities in years 5 and 6, measuring to be approximately 500mm</p>	<p>It would be beneficial for wheelchair users to convert the doors identified to door and a half systems. This would allow wheelchair users a greater clearance width when using the master leaf.</p> <p>☐</p> <p>Refer to BS8300 - An effective clear width of less than 800 mm may result in people with poor manoeuvring ability or with large wheelchairs not being able to pass through without damage to themselves or the door. Use of the preferred effective clear width more easily accommodates people with assistance dogs and where there is heavy pedestrian traffic.</p>	<p>M</p>

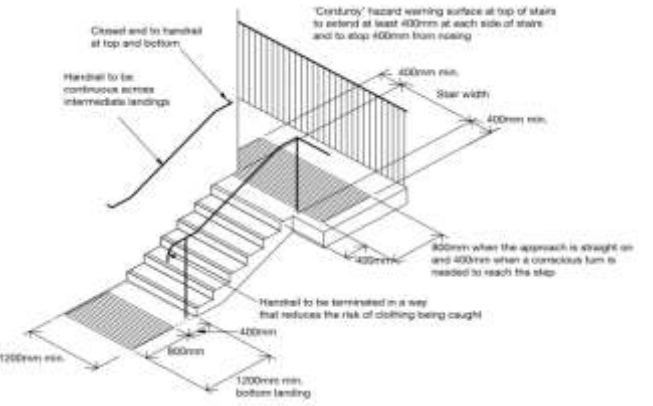
<p>2.7</p>	<p>Minimal lighting was identified in the car park. Are all bays adequately lit during darker hours?</p>	<p>Site management to undertake investigation of the lighting levels within the car parking areas during darker hours to ensure that they are sufficient.</p>	<p>N</p>	<p>Lighting acceptable in main car park, floodlights, school carpark lit by extrnal wall lighting.</p>
<p>4.1</p>	<p>The steps leading towards the key stage two playground featured tactile paving.</p> <p>The steps near to room 161 and those leading near the main entrance, did not feature tactile paving to provide warning of the first and final step.</p>

<p>Install tactile paving to the top of the external steps throughout the site.</p> <p>BS8300 - To give advance warning of a step, tactile paving with a corduroy hazard warning surface should be provided at the top and bottom of each flight, excluding intermediate landings with continuous handrails. Where the approach to the stair is wider than the flight, the tactile surface should extend beyond the line of each edge of the flight.</p>	<p>M</p>

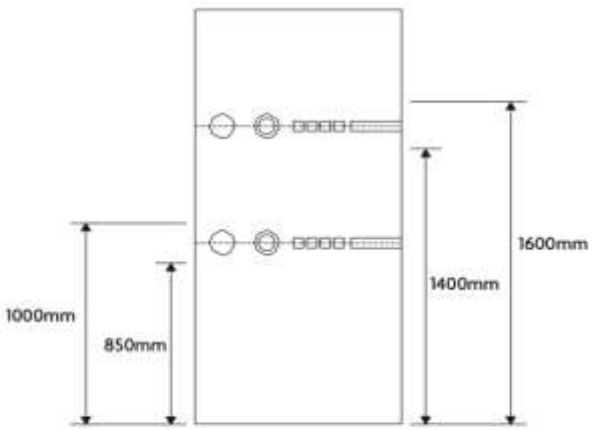
<p>5.9</p>	<p>Not applicable for the main entrance.</p> <p>The double doors leading into entrance near room 42 were glazed with no manifestations and could be a collision hazard.</p>

<p>1000mm 850mm 1400mm 1600mm</p> <p>Manifestation can take various forms, e.g. broken or solid lines, patterns or company logos</p>	<p>All full height glazed areas must be clearly highlighted with manifestation that contrasts visually with the surface behind it under both natural and artificial lighting conditions, from all likely viewing directions. This manifestation should be located within two zones, from 850mm to 1000mm from the floor and from 1400mm to 1600mm from the floor.</p>	<p>M</p>
