# Beckfoot Heaton School - Accessibility Action Plan.

Updated: 10/01/2025

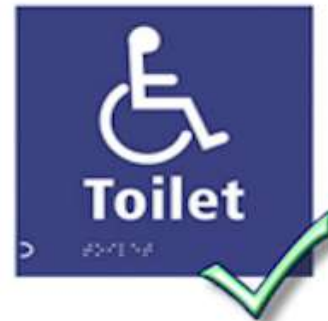
The signage on facility 42 was slightly damaged.

All accessible WC door signage should ideally be accessible to all disabled people with Braille and embossed lettering preferred.

Raised lettering / Braille Toilet signs added to 3 doors 263,270 & 171

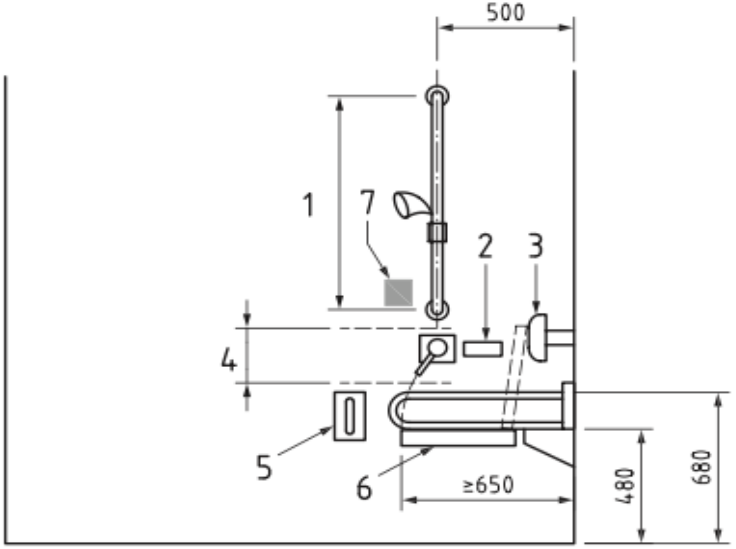
12.8 cont.

12.8	<p>A level access shower was identified in Hygiene Room 270. This facility did not feature a drop-down chair or contrasted grab rails. A hoist system was also provided to this facility.</p> <p>The student coat storing areas did not feature areas with lowered coat hooks, which could assist people who are short in stature.</p>	<p>A padded tip-up seat should be securely fixed to the wall and drop-down support rails and grab rails for a self-contained shower/ changing area should be located as shown in Figure 37.</p> <p>It may be beneficial to provide clothes hooks at two heights, one level at 1050mm and the other at 1400mm above the floor.</p>	M

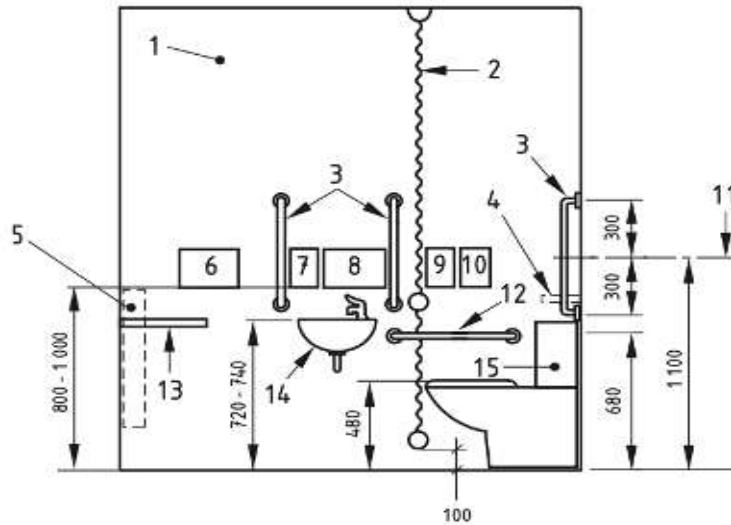
13.7 cont.

13.7	<p>Compartment 270 (the hygiene room) featured grab rails with minimal colour contrast, and a grab rail was missing to the left of the hand wash basin.</p> <p>A grab rail was missing to the left of the hand wash basin in the facility by years 5 and 6.</p> <p>The facility being refurbished featured grab rails that were not well contrasted to the top half.</p>	<p>The grab rail sets should be replaced with a new BS8300 compliant set that offers colour contrast. Alternatively, a contrasted background could be provided.</p> <p>A difference in LRV (Light Reflectance Value) between rail and background of 30 points is considered reasonable. In accessible WCs a blue rail set on white walls is a common accessible combination.</p> <p>Grab rails should be positioned as shown in BS8300 Figure 42:</p>	M

Height of drop-down support rails to be the same as the other horizontal grab rails.
